From: Burdett, Cheryl
Sent: Friday, November 15, 2013 2:28 PM
To: Rogers, Joan; Atkinson, Benjamin; Schwer, Don
Subject: FW: Info on suspected discharge at Prairie State Gilts CAFO in Schuyler County, IL
Attachments: ICCAW LTR to USEPA RE Suspected Discharge at Prairie State Gilts 11-14-13.pdf

Re: Suspected Illegal Discharge from Over-Application of Manure by Prairie State Gilt Farms, Schuyler County, Illinois

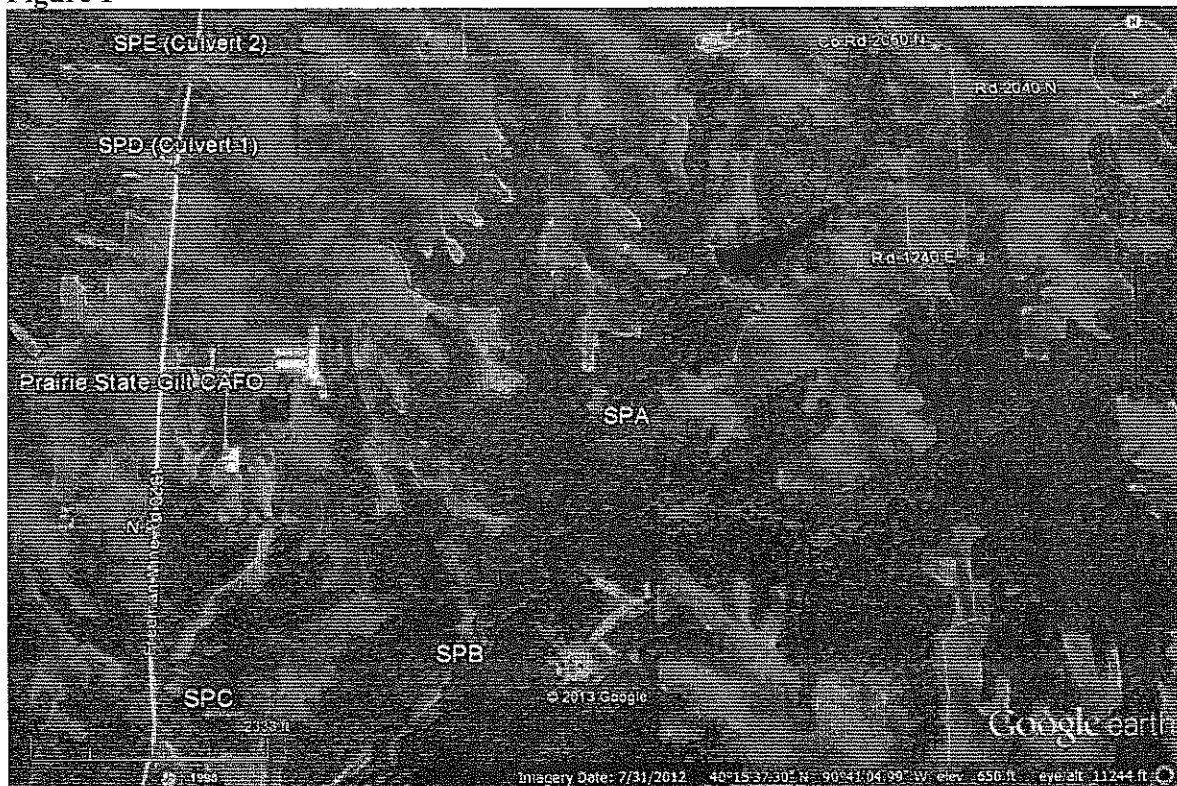
Prairie State Gilt Farms is located in Schuyler County along 1920 Road North and Freeman Mine Road, near the town of Doddsville, Illinois (coordinates: 40°15'37.15"N, 90°41'49.07"W). The location of the facility is displayed in Figure 1 (on page 2 below).

Prairie State Gilt Farms is a farrowing facility. It holds 3,600 sows and additional piglets. According to the knowledge and belief of local residents, the facility has applied waste only on the same 210 acres of land for the past 17 years. This land application area is identified by the area outlined in red in Figure 1.

During the October 31, 2013 water testing, the Exemption 6 member collected water from three separate sample points south of the Prairie State Gilt facility. The sample point locations are shown in Figure 1 as Sample Points A-E, hereinafter SPA-E. For comparative purposes, SPA-SPC and SPE are shown in Figure 2 (beginning on page 3 below). SPA is an upstream sample point. SPA shows clearer water with little to no discoloration compared to water downstream. SPB, SPC and SBE show evidence of brown, turbid water running into the receiving creek, indicating runoff from the land application area.

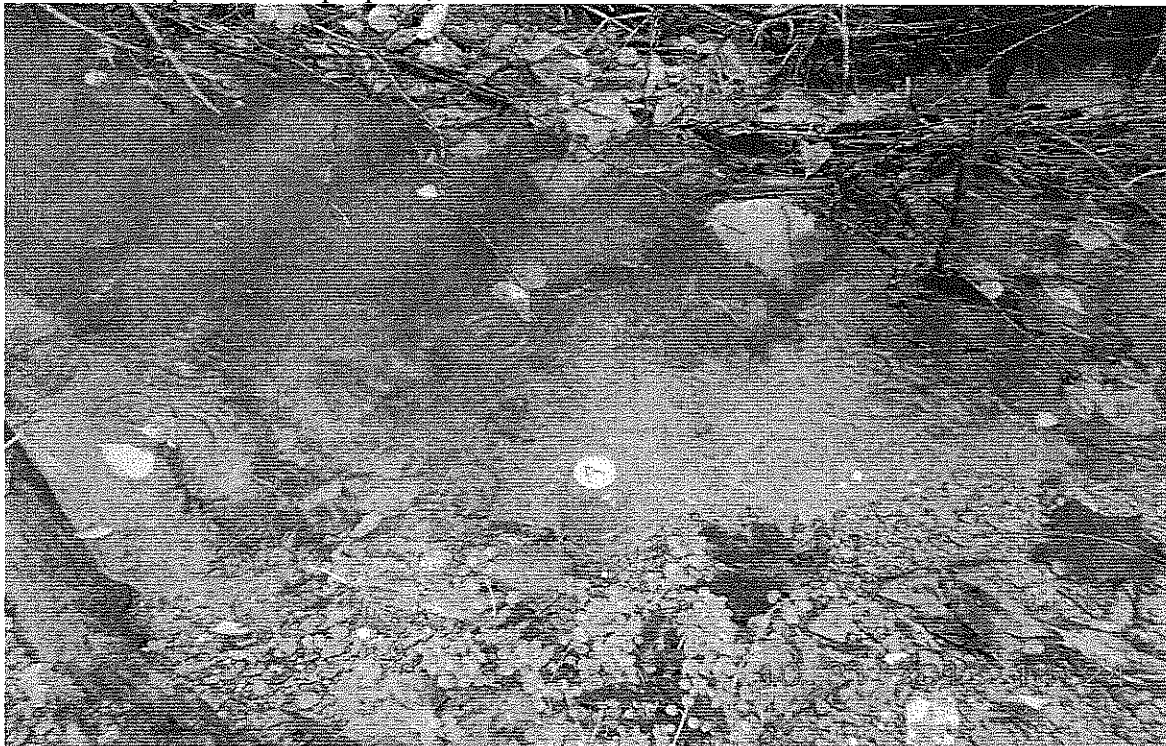
Figure 2

SPA – clear upstream sample point, with water collected in bottle.

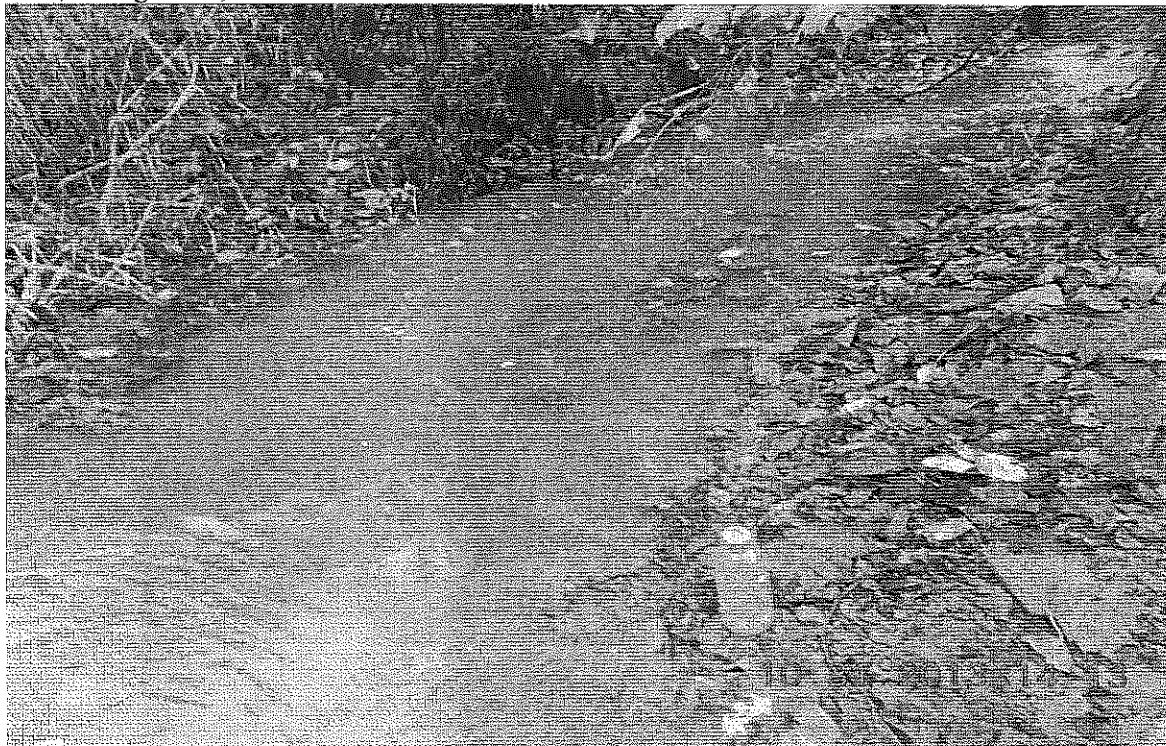
The Exemption 6 member tested for levels of nutrients, i.e., phosphate, ammonia, nitrate, and nitrate, from the water from SPB and SPC with an eXact Micro 7+ meter. Photos in Figure 2 display the collected water. Water testing results are included in a data log, which are provided in Figure 3 (beginning on page 5 below). The results show high levels of phosphate and ammonia, and low levels of nitrite and nitrate.

SPB, facing north, with water collected in bottle.

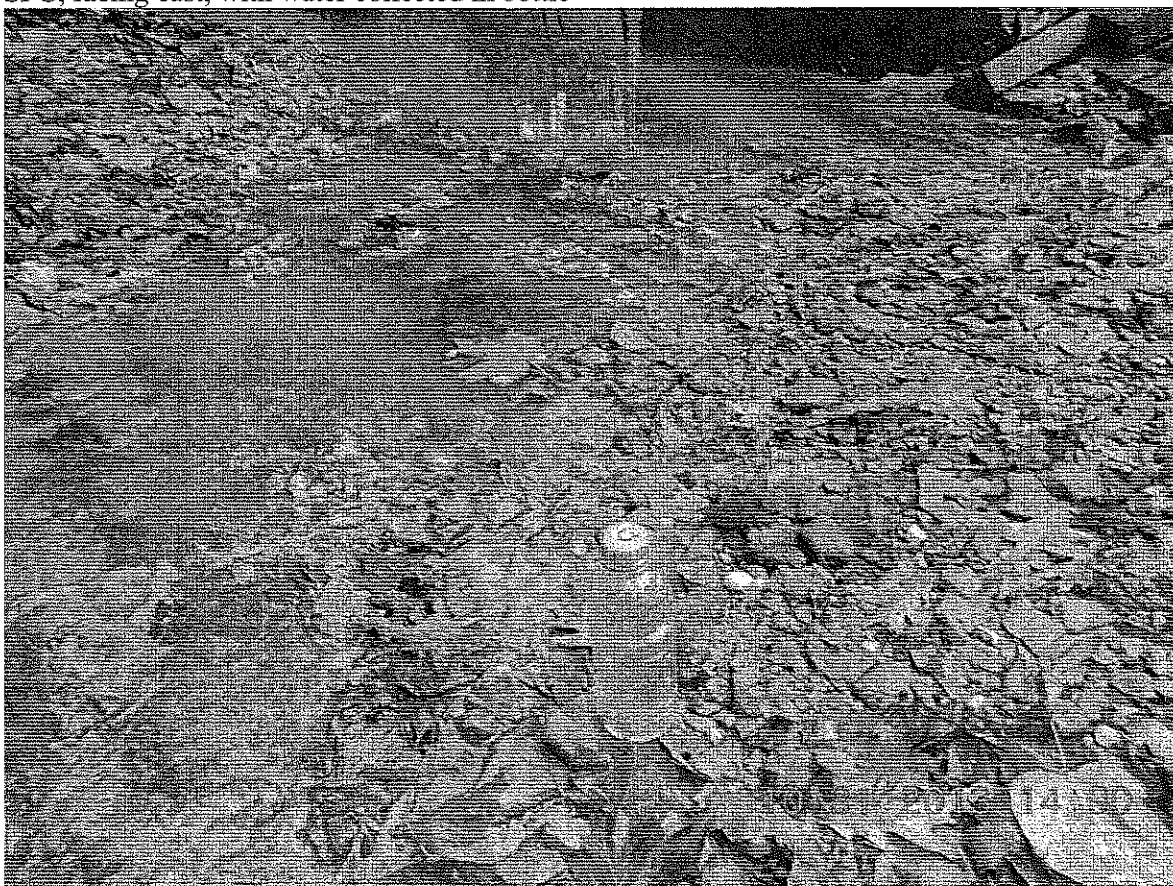
SPC, facing east, with water collected in bottle

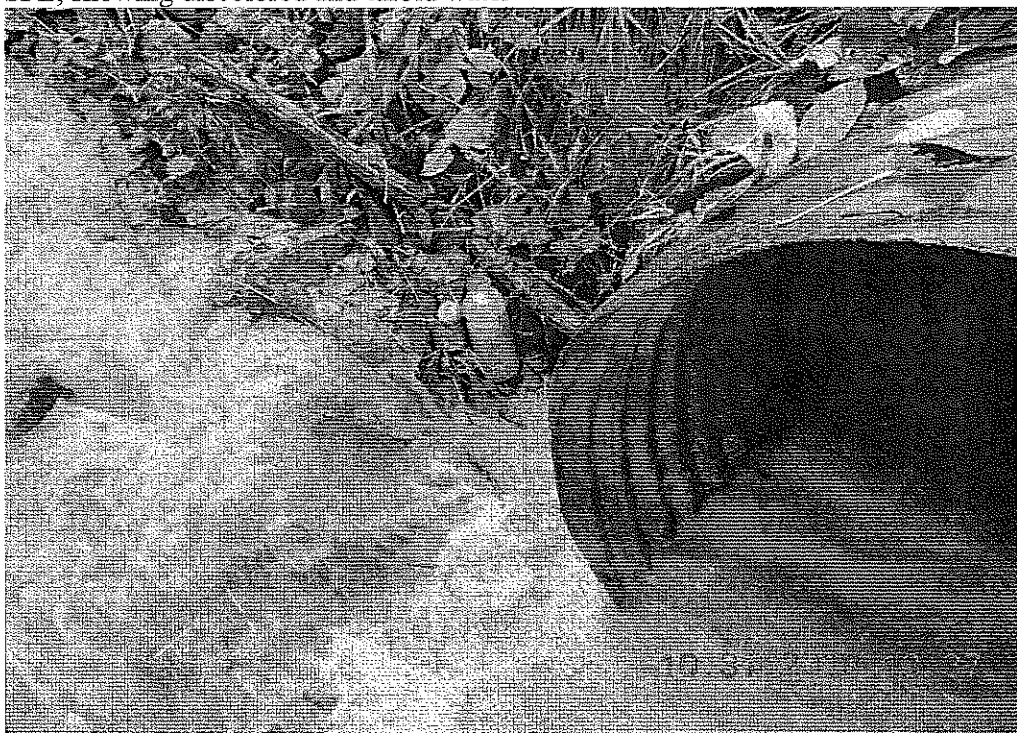
SPE, showing discolored and turbid water

Again, we make this request of USEPA to immediately conduct a compliance inspection at the facility, because we are concerned that this facility poses an immediate threat to nearby waters. We request that you conduct a compliance inspection at this site as soon as possible in order to ensure that the facility complies with the Clean Water Act's permitting requirements.
